Subject: Report of Inspection, LAVWMA Export and Storage Facility, Order R2-2021-0007 (NPDES Permit CA0038679), Pleasanton, Alameda County

NPDES Compliance Evaluation Inspection (CEI) Report

Photo Log

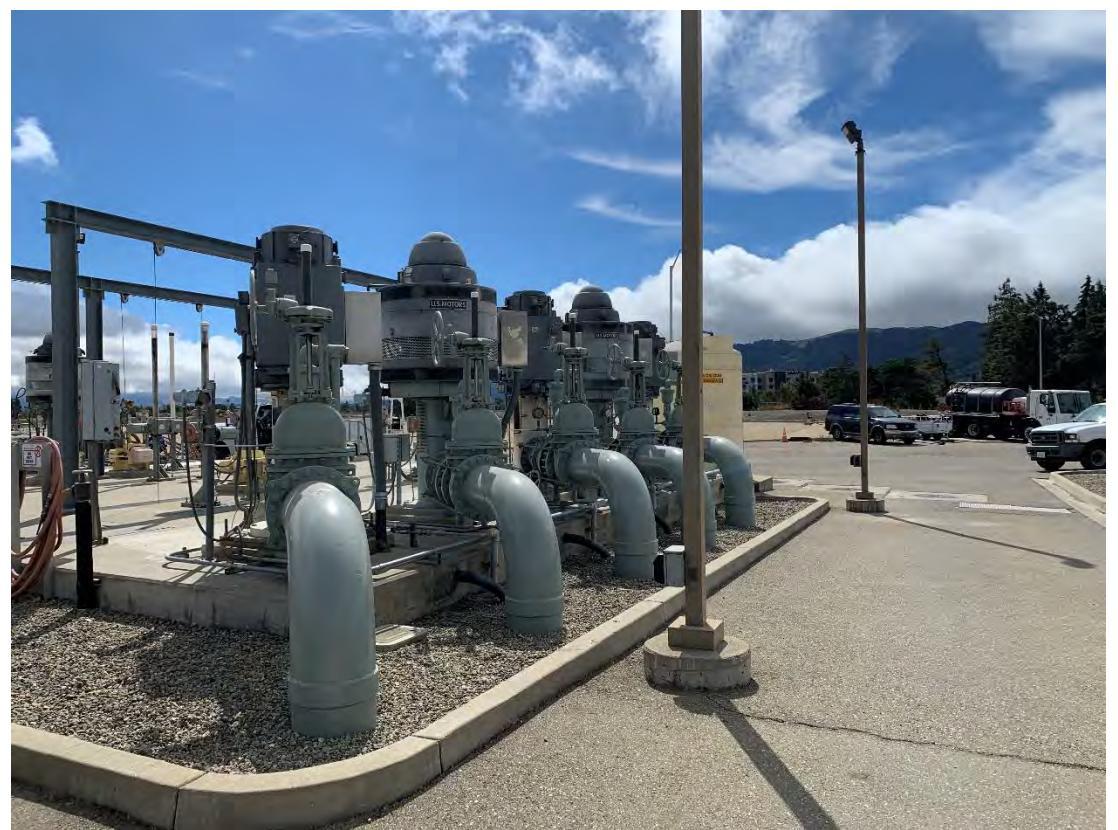
Figure 1. LAVWMA pump station.

During the inspection, the facility appeared well-kept and the LAVWMA Export Pump Station appeared in good working order, consisting of four 5 million gallon-per-day (MGD) and six 4.5 MGD pumps that provide up to 47 MGD of total pumping capacity. According to LAVWMA's General Manager, the Facility will replace Pumps 1, 3, and 5 in October 2023 because the pumps are approaching the end of their lifespan. The new pumps are expected to have improved efficiency and a longer lifespan than rebuilt pumps.

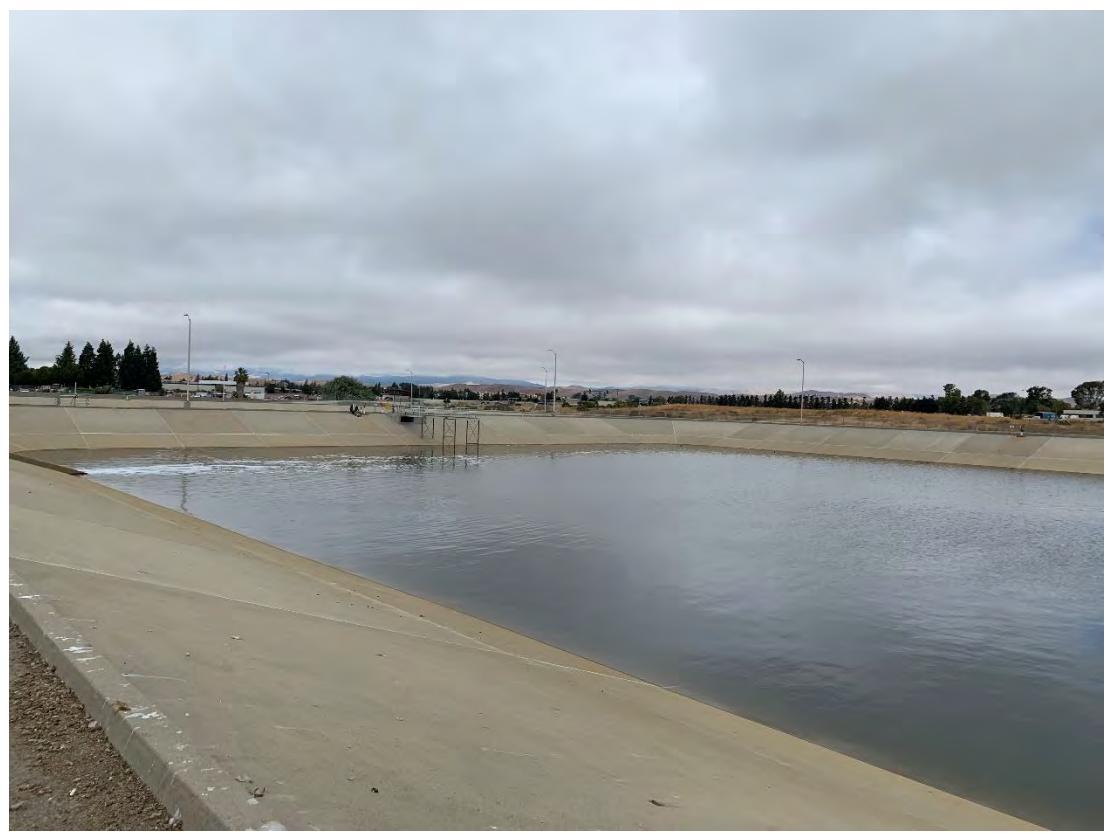
Figure 2. Fully treated wastewater from the City of Livermore and DSRSD treatment plants is combined and then flows through the middle gate (Figure 3), which equalizes wastewater flows between the Facility's equalization basins.

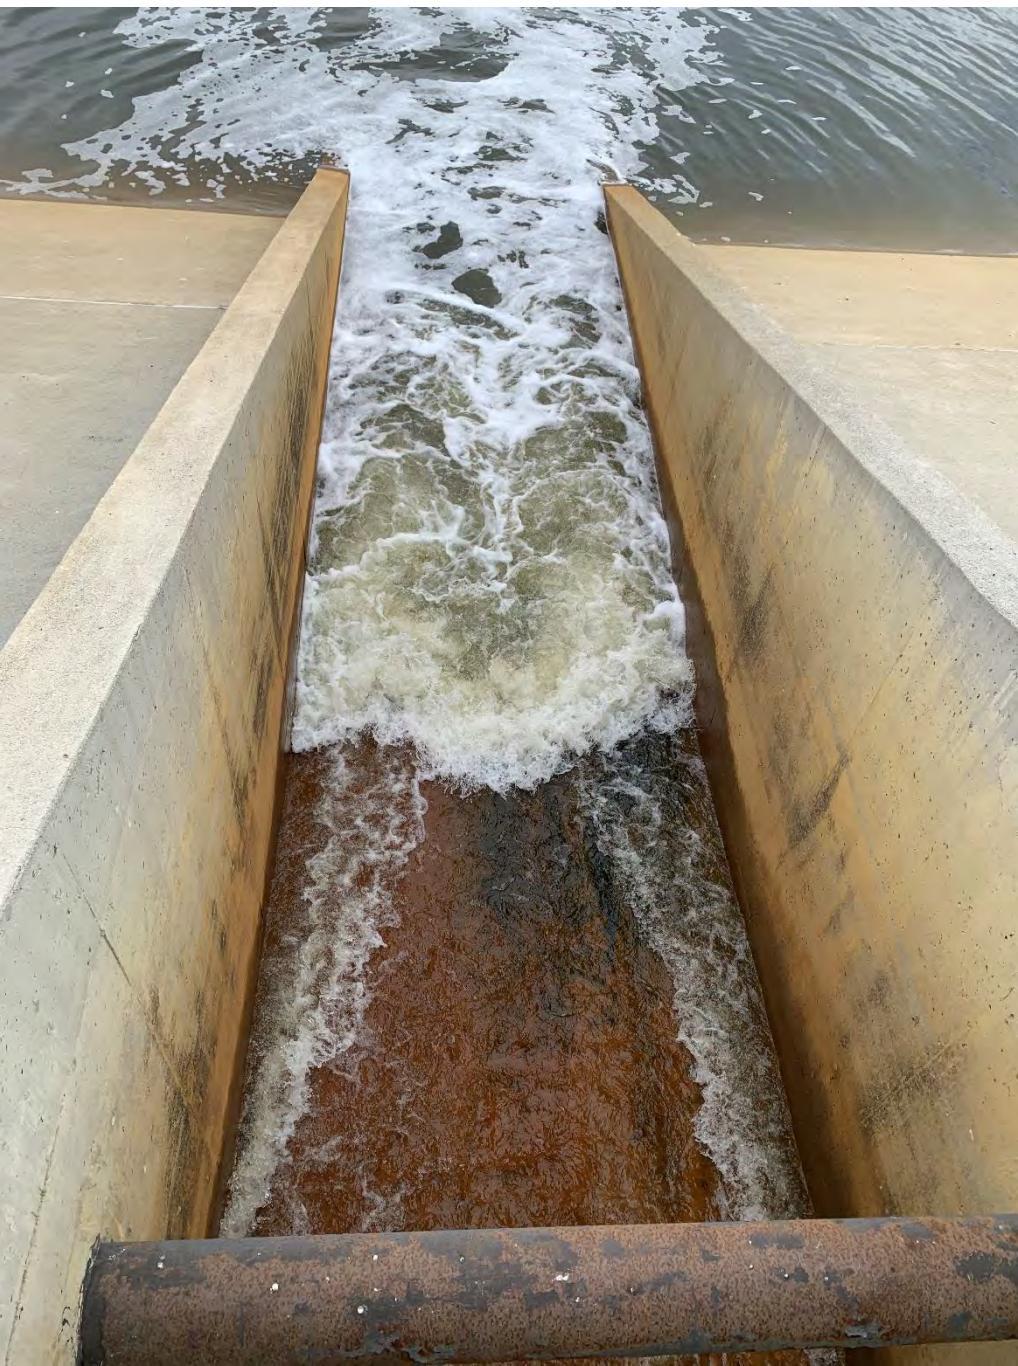
Figure 3. Middle gate of equalization basin.

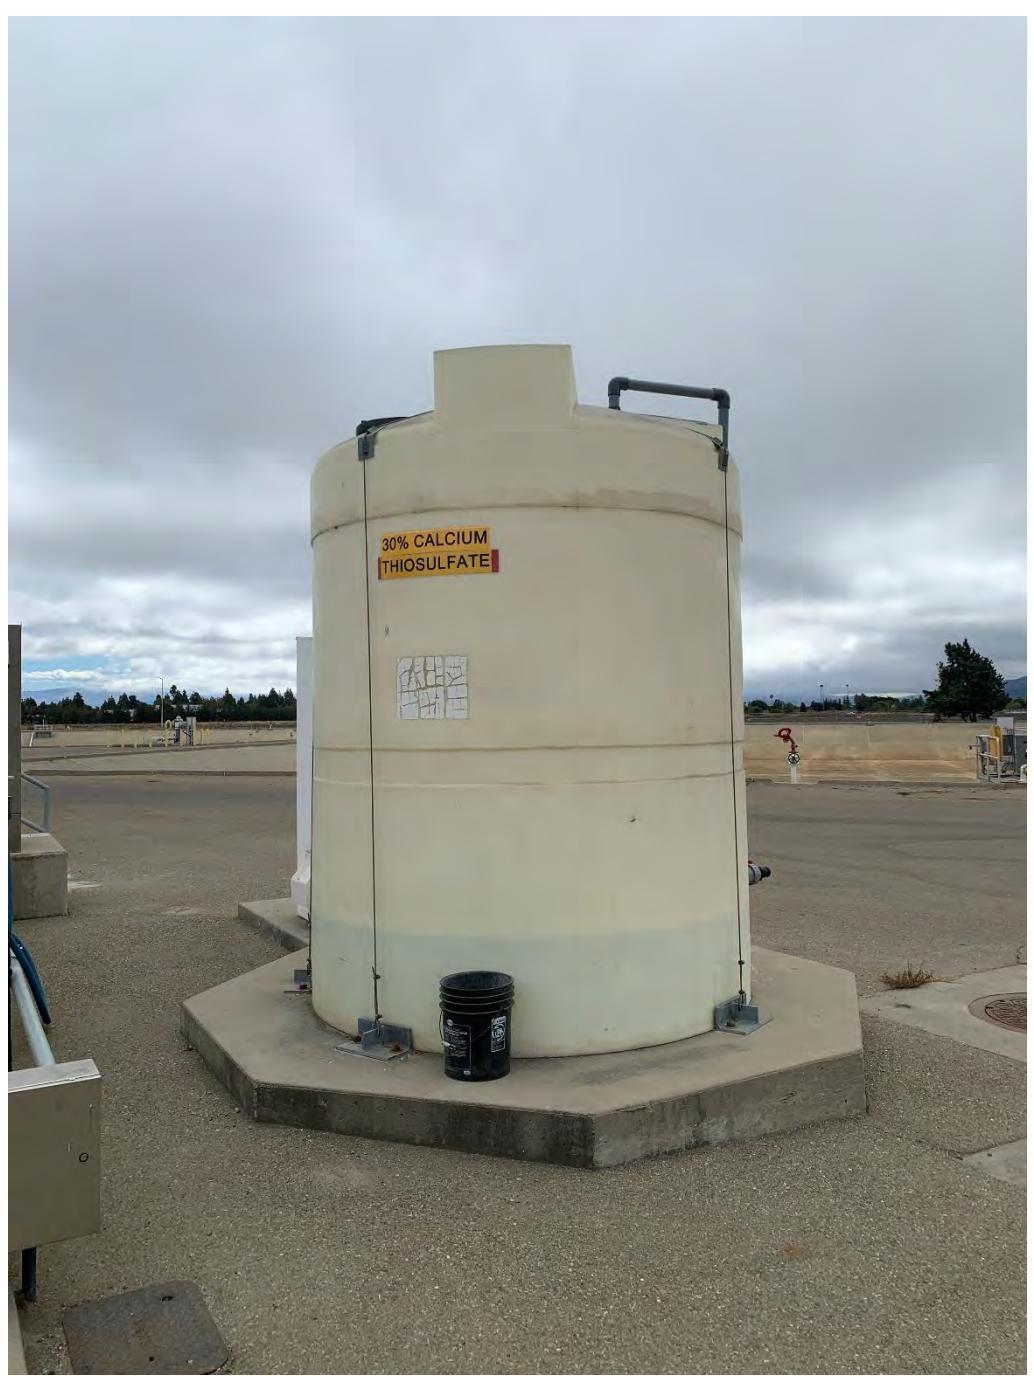
Figure 4. Calcium thiosulfate, for dechlorinating wastewater during wet weather discharges or discharge exercises, was stored within a double-lined container.

The only chemical stored onsite, calcium thiosulfate, was within a double-lined container. During the inspection, the Operations Superintendent demonstrated operating the SCADA system, which could control operations at both the DSRSD treatment plant and the Facility. A hardcopy of the Facility's Wet Weather Operation Strategy was posted next to the SCADA control station. The Facility last updated the Wet Weather Operation Strategy on December 13, 2022, and plans to review it again in November 2023.

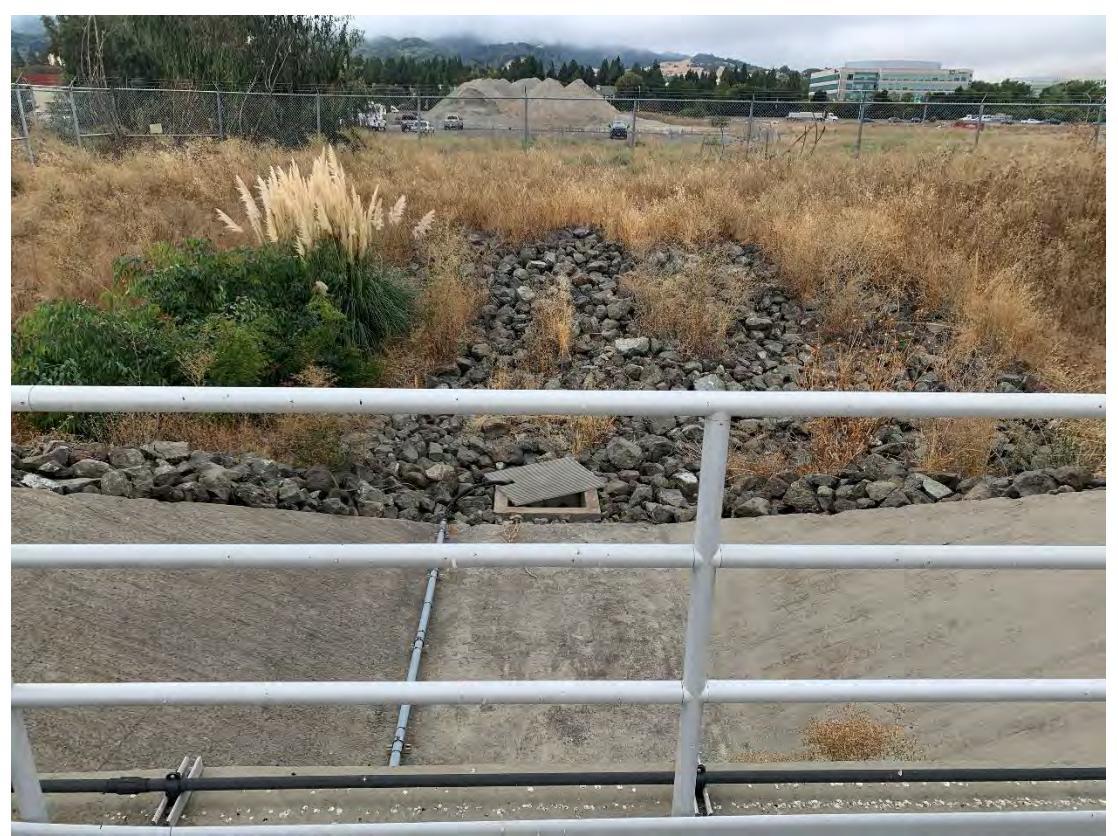
Figure 5. One of LAVWMA's two wet weather outfalls. This one discharges to Alamo Canal.
